**DEPARTMENT OF TRANSPORTATION**

Office of Structural Materials

Contract #: 04-0120F4Cty: SF/ALA Rte: 80 PM: 13.2/13.9File #: 69.28**WELDING INSPECTION REPORT****Resident Engineer:**Siegenthaler, Peter**Address:** 333 Burma Road**City:** Oakland, CA 94607**Report No:** WIR-018809**Date Inspected:** 19-Dec-2010**Project Name:** SAS Superstructure**OSM Arrival Time:** 700**Prime Contractor:** American Bridge/Fluor Enterprises, a JV**OSM Departure Time:** 1900**Contractor:** Zhenhua Port Machinery Company, Ltd (ZPMC), Changxing Island **Location:** Shanghai, China**CWI Name:** Li Yang**CWI Present:** Yes No**Inspected CWI report:** Yes No N/A**Rod Oven in Use:** Yes No N/A**Electrode to specification:** Yes No N/A**Weld Procedures Followed:** Yes No N/A**Qualified Welders:** Yes No N/A**Verified Joint Fit-up:** Yes No N/A**Approved Drawings:** Yes No N/A**Approved WPS:** Yes No N/A**Delayed / Cancelled:** Yes No N/A**Bridge No:** 34-0006**Component:** OBG Segment**Summary of Items Observed:**

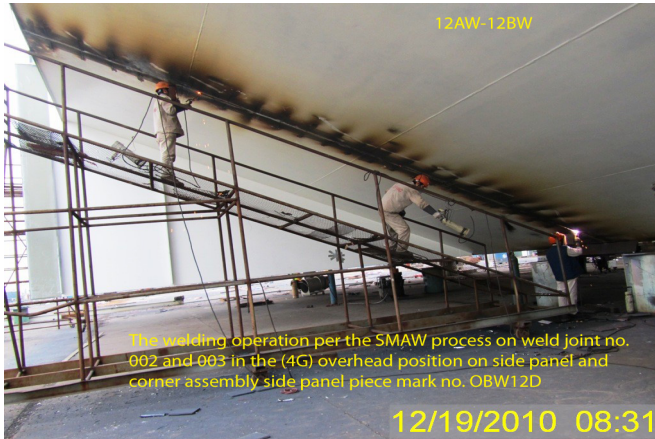
The QA Inspector observed the welding operation per the SMAW process on weld joint no. 003 in the (4G) overhead position on corner assembly side panel piece mark no. OBW12D. The location was the transverse splice weld joining segment 12AW and 12BW at work point W4 to W6. The welder ID was 046709. The ZPMC CWI was identified as Li Yang. The welding variables recorded by QC appeared to comply with the WPS-B-P-2214-B-U2-FCM-1.
